SAN DIEGO FLEET MOORINGS INSPECTION REPORT

30 NOVEMBER

OCEAN ENGINEERING AND CONSTRUCTION PROJECT OFFICE
CHESAPEAKE DIVISION
NAVAL FACILITIES ENGINEERING COMMAND
WASHINGTON, DC 20374

FPO-1-82 (29)

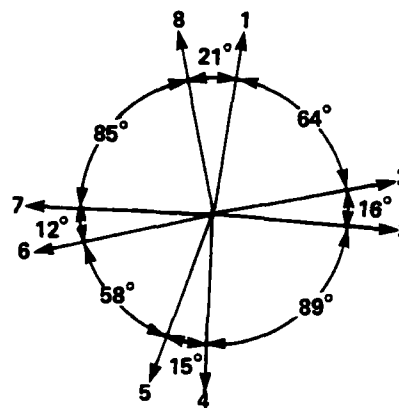
MOORING NO.: FM-20 CLASS: BB LOCATION: HARBOR ISLAND LAT: _____ LONG: _____
 WATER DEPTH: 42' 39 1/2' TYPE MOORING: ☐ RISER ☐ TELEPHONE ANCHOR SIZE/TYPER: N/S BUOY TYPE: DRUM
 DATE: 8/18/82 ENGINEER-IN-CHARGE: M. WALTER DIVER: J. TORRENS, J. S. HARRING 16' d 49" F.B.

This mooring is considered it to be in satisfactory condition.

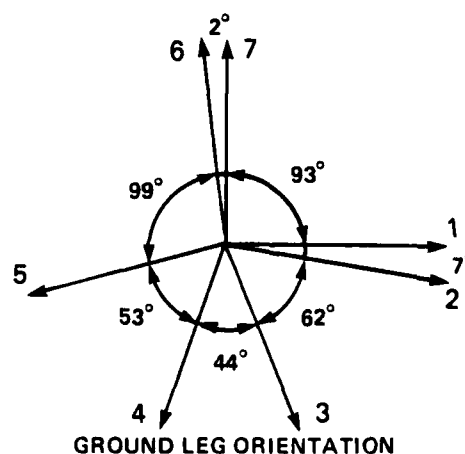
MOORING NO.: EM 21 CLASS: BB LOCATION: HARBOR ISLAND LAT: _____ LONG: _____

Resulting from the two ground legs with >80% readings it is recommended that this mooring be downgraded. However, this mooring does not fall into any standard classification and no estimate of its holding capacity is specified.

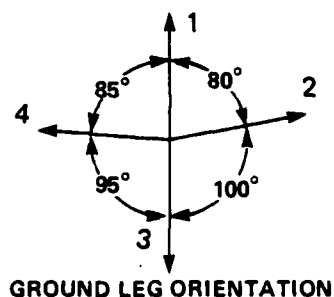
MOORING NO.: EM-18 CLASS: B LOCATION: NAVSTA LAT: LONG:

Resulting from double link chain measurements of $>80\%$, it is recommended that this mooring be downgraded. However, this mooring does not fall into any standard classification and no estimate of its holding capacity is specified.

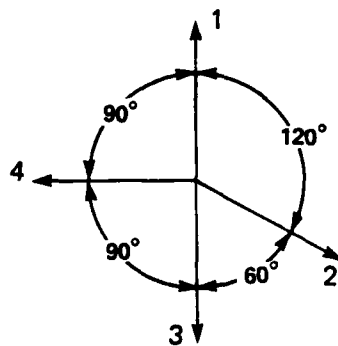
MOORING NO.: EM-50 CLASS: B LOCATION: NAVSTA LAT: LONG:

This mooring, as a Class B fleet mooring, has been found to be in satisfactory condition.

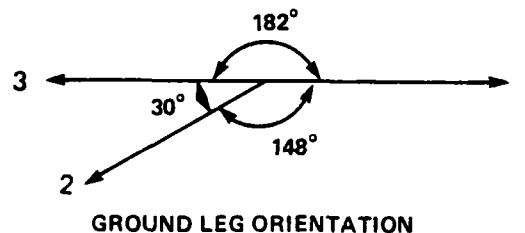
MOORING NO.: EM 51 CLASS: B LOCATION: NAVSTA LAT: LONG:

This mooring, as a Class A fleet mooring, has been found in satisfactory condition.

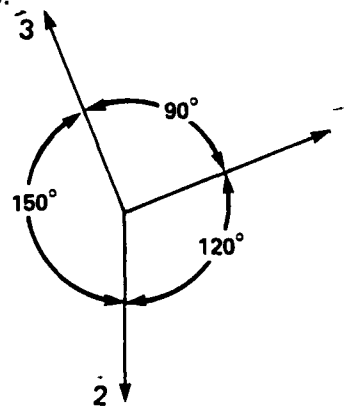
MOORING NO.: T-2 CLASS: E LOCATION: BALLAST PT. LAT: _____ LONG: _____
 WATER DEPTH: 32' / 28' TYPE MOORING: ☒ RISER ☐ TELEPHONE ANCHOR SIZE/TYPER: N/S BUOY TYPE: DRUM
 DATE: 8/23/82 ENGINEER-IN-CHARGE: M. WALTER DIVER: B. NELSON, J. JARRENS 10' Ø 33" F.B.

Divers measured 2 1/2 inch mooring chain, which indicates a Class B mooring, according to DM-26. Records indicate San Diego uses this mooring as a Class E fleet mooring.

The chain on this mooring was found to have >80% of its original wire diameter remaining, which indicates a need to downgrade the mooring by one class. The resulting Class C is still higher than the Class E required so this mooring should be adequate for its intended use.
